U.S. ARMY CORPS OF ENGINEERS U.S. GOVERNMENT MOORINGS FACILITY CSM Site Summary

U.S. MOORINGS

Oregon DEQ ECSI #: 1641

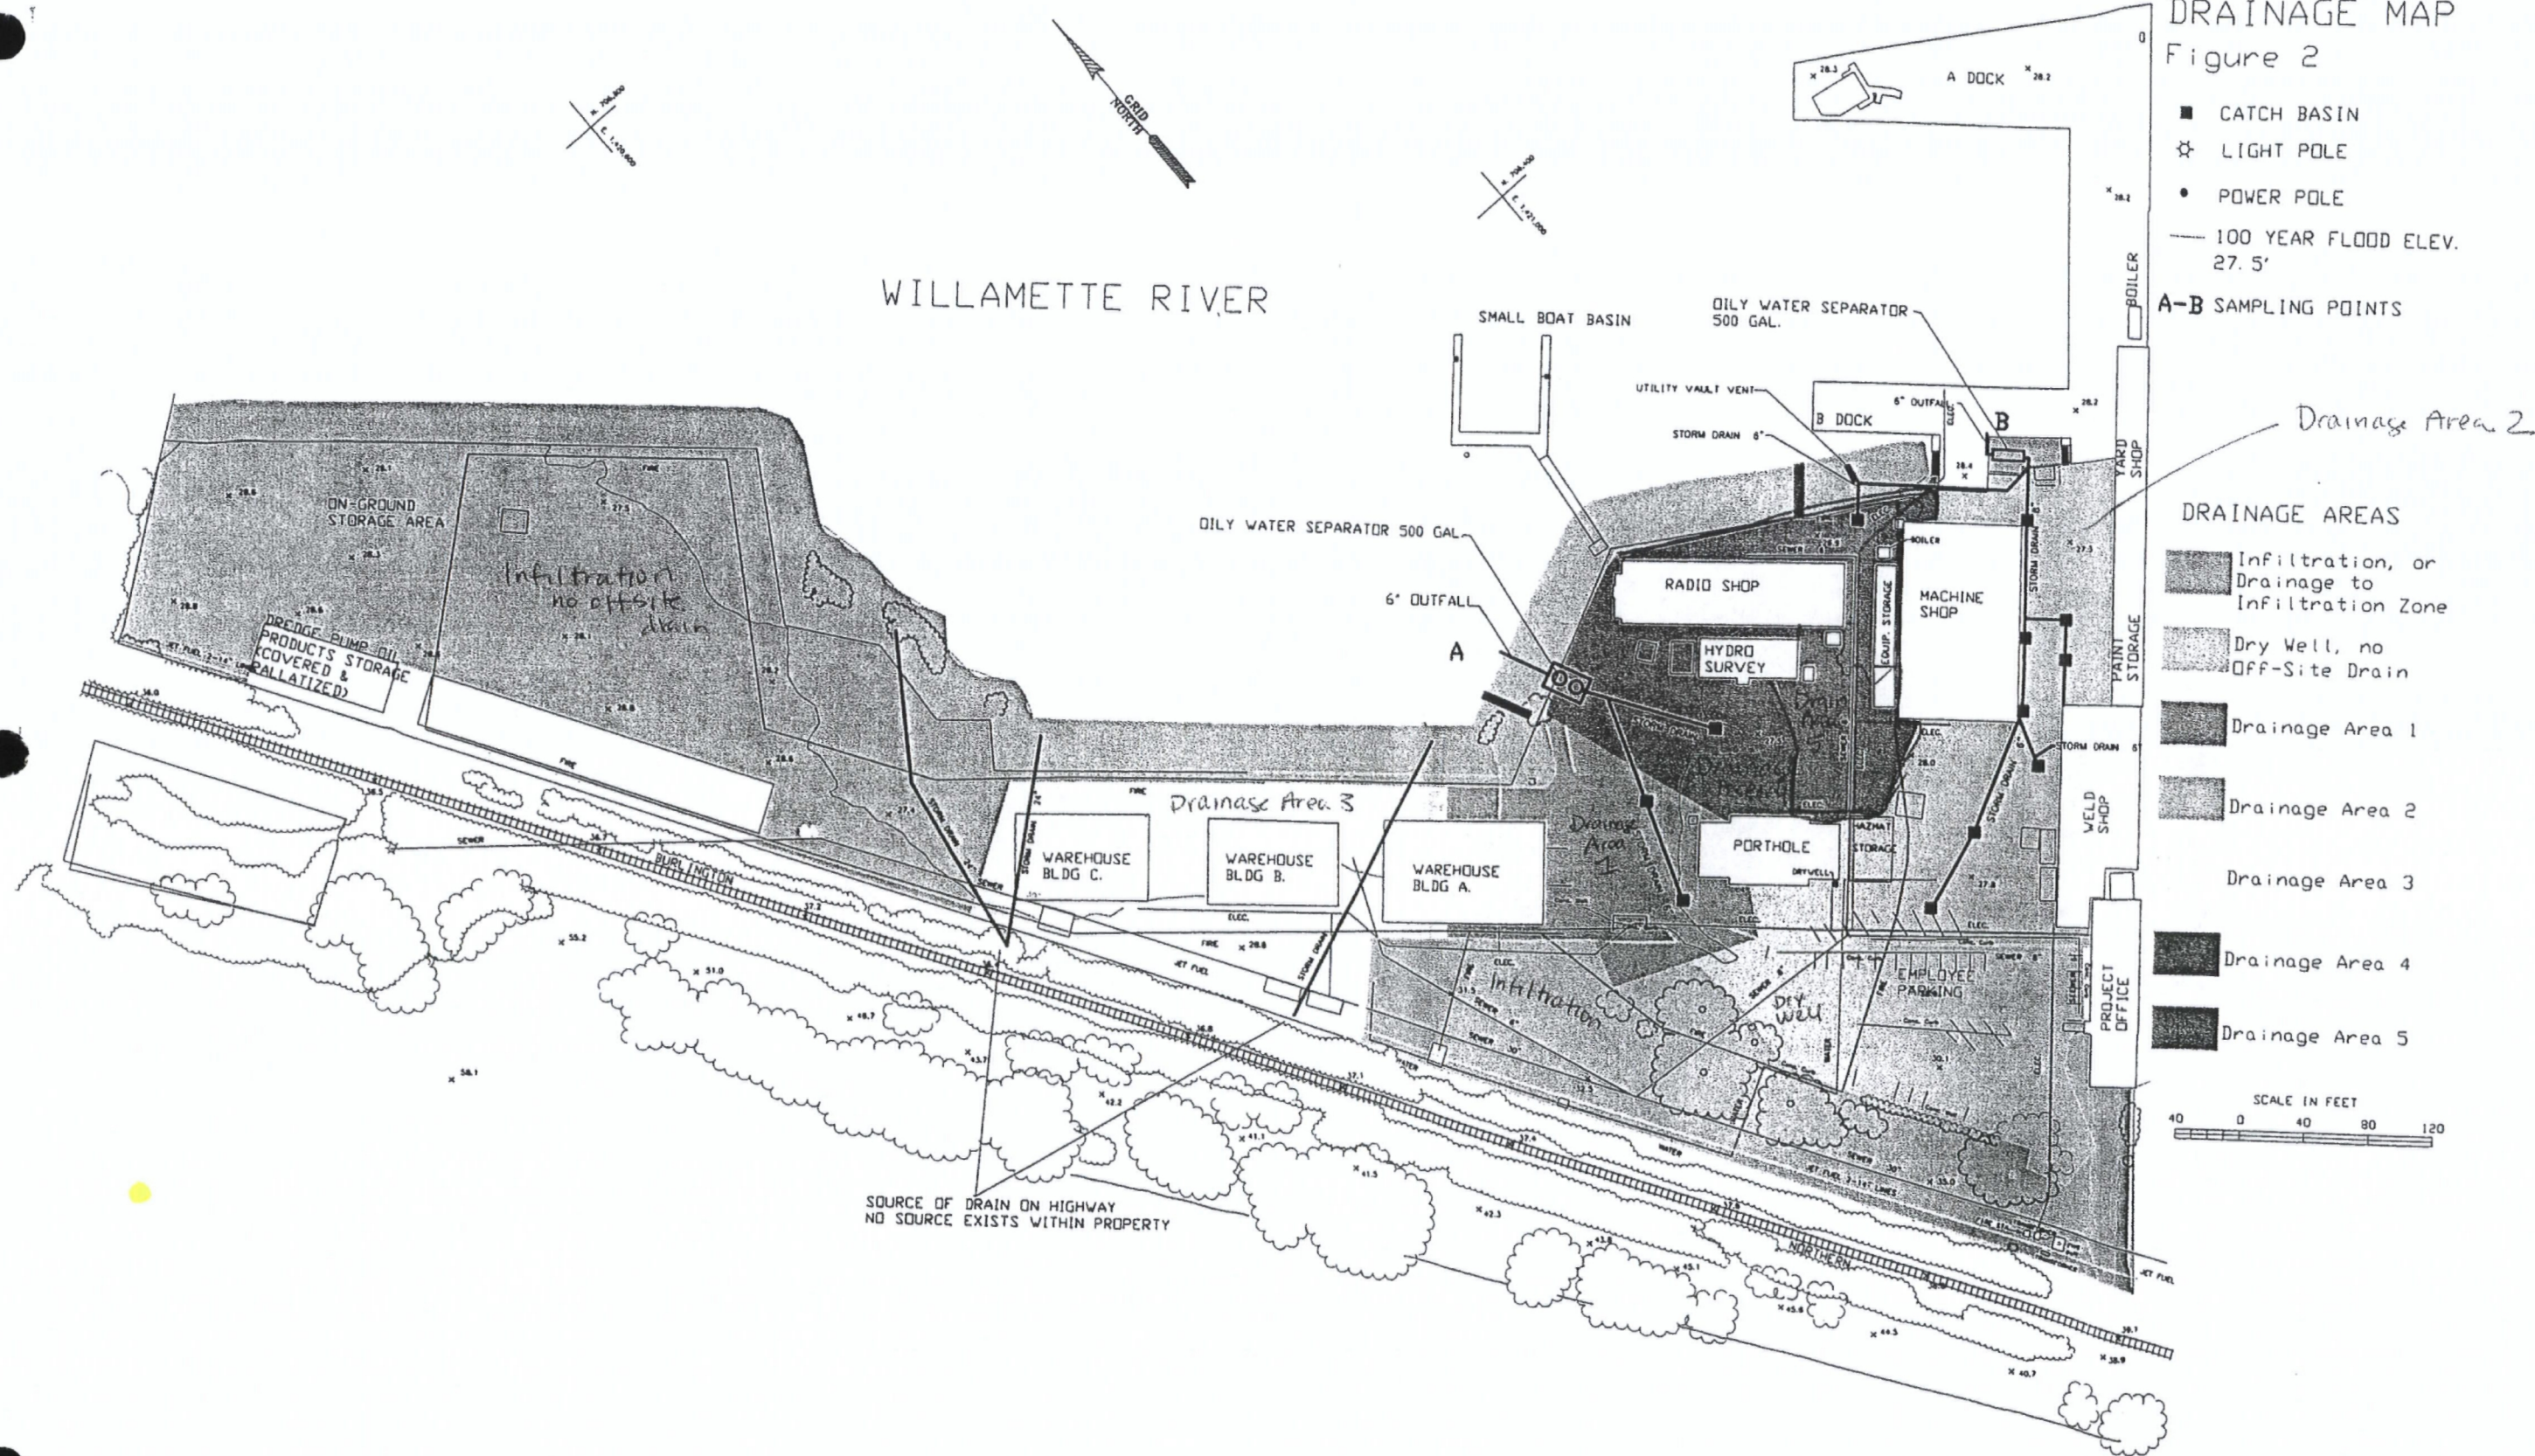
U. S. MOORINGS DRAINAGE MAP Figure 2

The eastern half of the site's 13.14-acre area is covered by asphalt pavement and consists of five drainage areas as shown in Supplemental Drainage Map from USACE (2002). Drainage Areas 1 and 4 discharge to a 6-inch outfall (Outfall A) near Dock C. Drainage Areas 2 and 5 discharge through a 6-inch outfall (Outfall B) located near Dock B. It is not

clear from the map how stormwater drains from Drainage Area 3. Stormwater associated with drainage areas 1, 2, 4, and 5; drains within some buildings; and the parking lot drains pass through 500-gallon oil/water separators before being discharged through Outfalls A and B into the river. No malfunction or overload of the oil/water separator system has occurred according to site personnel, and the system is maintained on an annual basis. All stormwater runoff from the U.S. Moorings is discharged into the Willamette River (DEQ 2004b). Other outfalls exist along the site's shoreline, as shown in Figure 1; however, it is not clear which outfalls correspond with Outfalls A and B shown in Supplemental Drainage Map from USACE (2002) (i.e., City of Portland outfall nomenclature can not be corroborated with the USACE nomenclature). In addition, some outfalls noted in Figure 1 may be associated with highway drains, as described in the Supplemental Drainage Map from USACE (2002).

Stormwater infiltrates the ground in the western half of the site or is collected in catch basins distributed in five drainage basins in the eastern half of the site. Three outfalls receive stormwater from the five drainage areas and discharge directly into the Willamette River as shown in Supplemental Drainage Map from USACE (2002).
